4B GROUP

Grain Securing Overlap Belt Splices

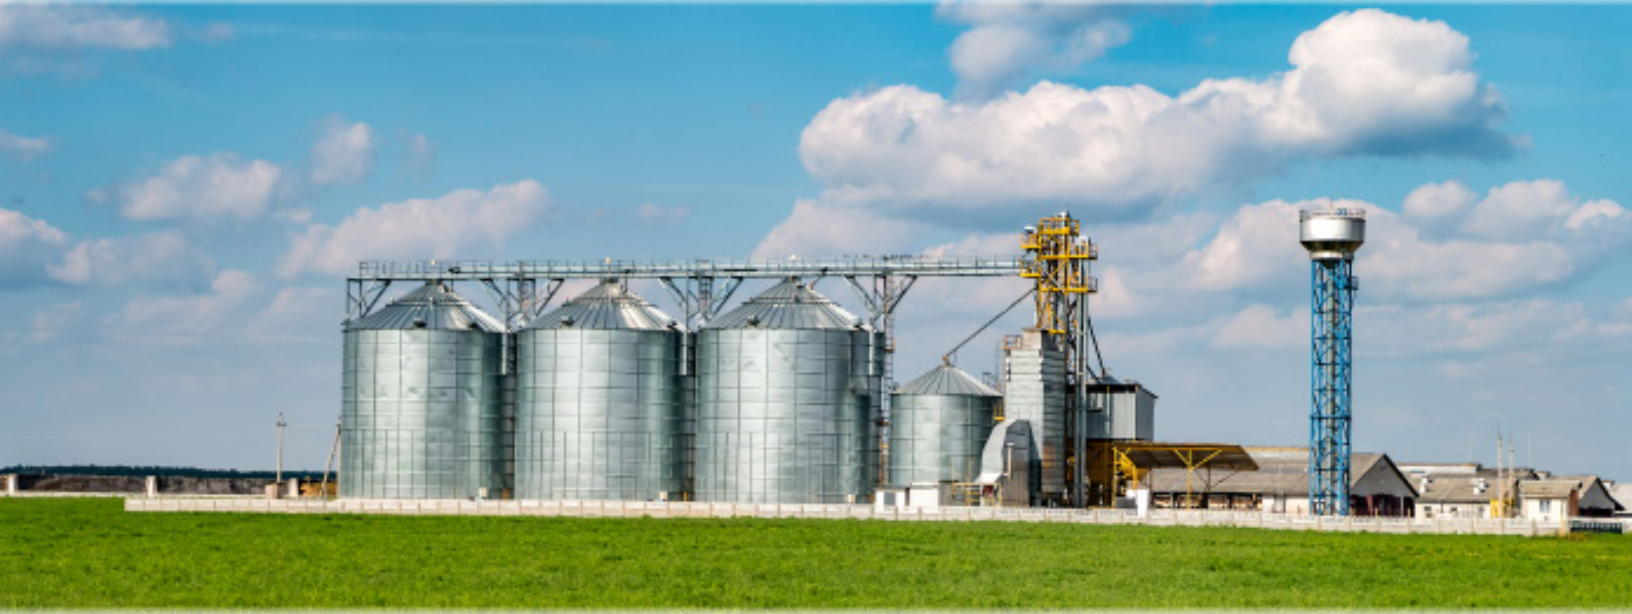
OVERLAP BELT SPLICE

A grain storage facility of a large North American trading company was concerned that the bolts used to secure the overlap splice section of an elevator leg belt were prone to pull through. The nature of an overlap splice generates additional stress on the bolts in many ways. The two layers of belting are subjected to uneven contact force from the drive pulley. This makes the inside belt flex more than the outside belt. Additionally, the weight of the loaded elevator buckets pulls on the splice bolts. The bolts can snap or the heads can pull through the belt. A compromised belt splice can diminish efficiency and in the worst case, drop a fully loaded belt with buckets down the elevator leg casing and into the boot.

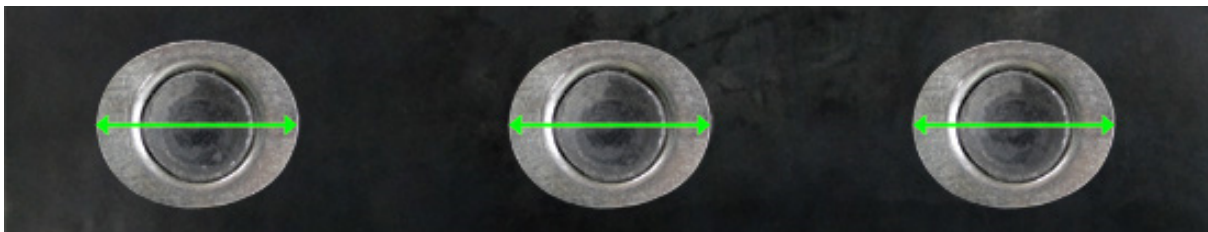
Reference 70 bolts (installed on the splice) with Reference 70 oval washers oriented horizontally across the belt to minimize stress as they pass around the pulley

The solution was twofold and encompassed using 4B brand Reference 70 elevator bolts. The elevator buckets normally secured to the belt used 5/16" diameter bolts. 4B Components supplied larger 3/8" diameter bolts for use on the overlap splice. The larger diameter bolts have a greater tensile strength to tolerate the environment of an overlap splice. Secondly, the Reference 70 bolts incorporate a unique oversized oval washer into the bolt head, which covers a large surface area on the belt, therefore spreading the pull-through force over a greater surface area. No other style of elevator bolt is able to cover such a large area of belt.
