## SUN RICE

Provide engineering, design guidance and component supply with changing old-style steel fabricated buckets to modern polymer buckets.

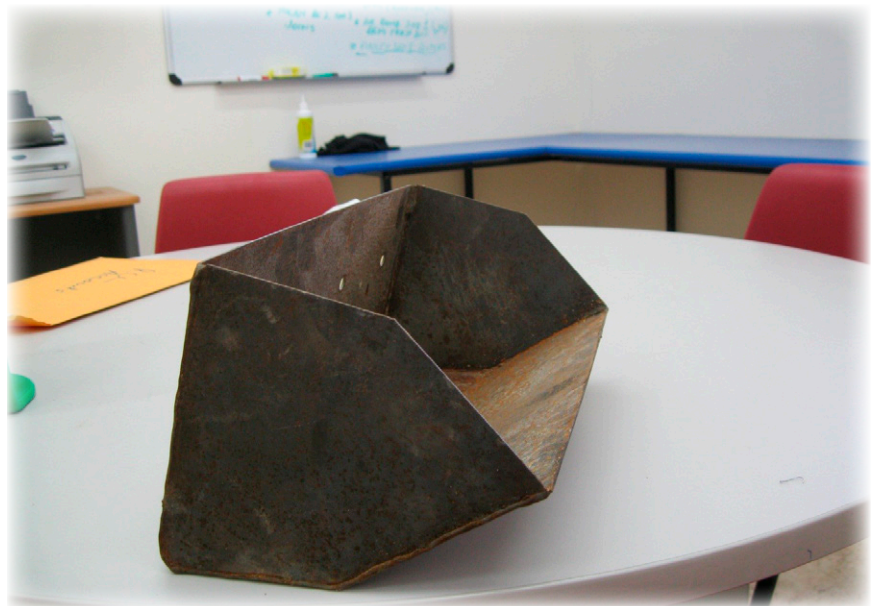
Image 1: Old Style Fabricated Steel Bucket

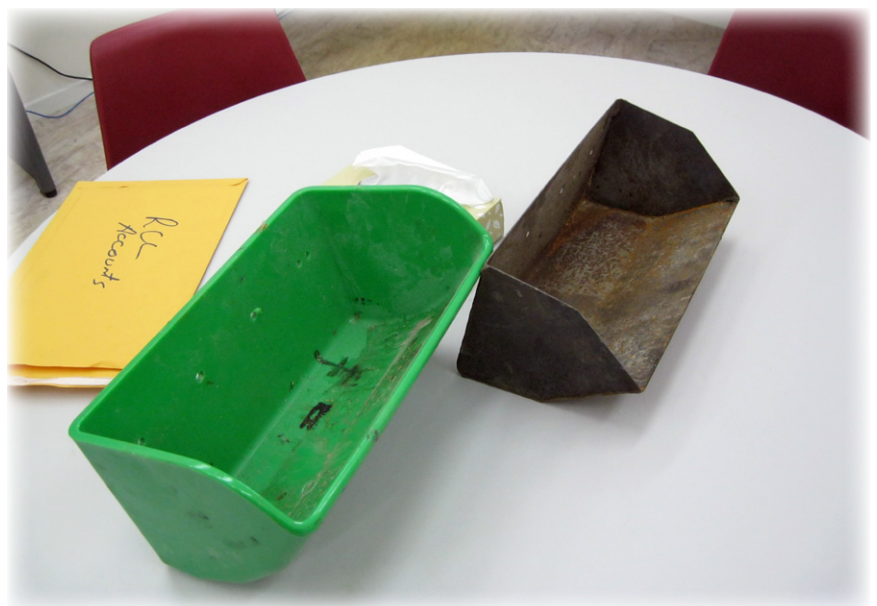
The older style fabricated steel buckets were of a similar geometry to CC type buckets. So, trials commenced utilizing several types of CC poly buckets, all of which proved to be inefficient and backlegged rice so significantly throughput was decreased by 40TPH and wear damage to the casings had occurred through the re-circulation of materials.

Image 2: Old Style Fabricated Steel Bucket & CC type bucket

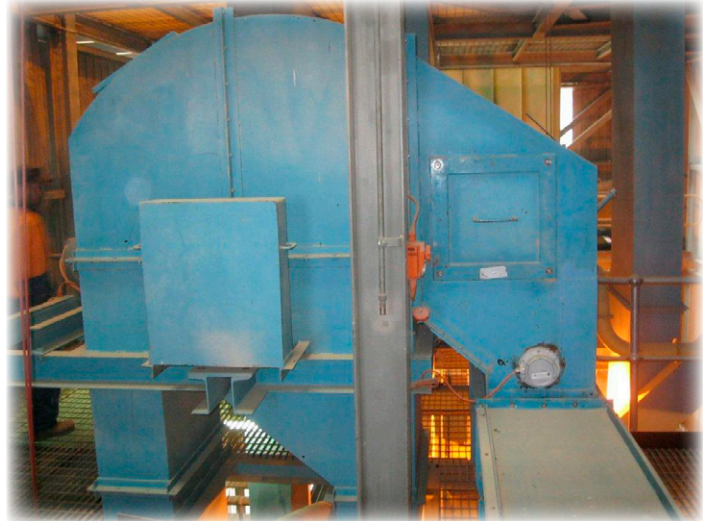
A complete and thorough evaluation was undertaken of belt and pulley speeds, discharge efficiencies and actual volumetric filling factors of individual buckets. This was then assessed against the existing discharge chute design, which favoured the older style steel fabricated buckets.

Image 3: Discharge Chute – Before modifications

The combined results provided 4B Engineers with the exact information required for selecting a suitable bucket, adjusting the angle of the outlet chute, applying a belt speed reduction. Which increased individual volumetric filling, and reduce backlegging.

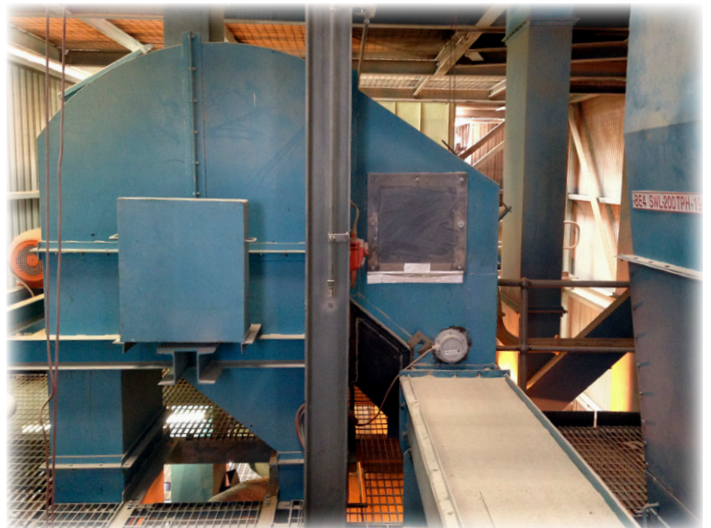
Image 4: Discharge Chute – After modifications

The 4B solution was able to deliver the benefits the customer was looking to achieve with their “continuous improvement” programme. The elimination of the backlegging, and chute wear whilst maintaining origin design capacity.

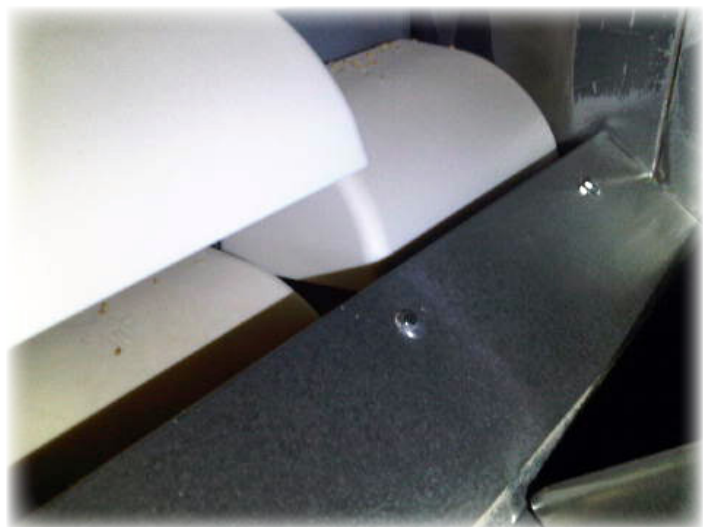
Image 5: SPS buckets installed

The versatile SPS bucket provided the best results due to wide range of speeds that it can be utilized in on most elevator applications. In this instance the elevator had been designed around an old bucket that was now considered inefficient in performance and costly to manufacture.
