## Peanut Production & Processing Reduce Elevator Downtime and Maintenance

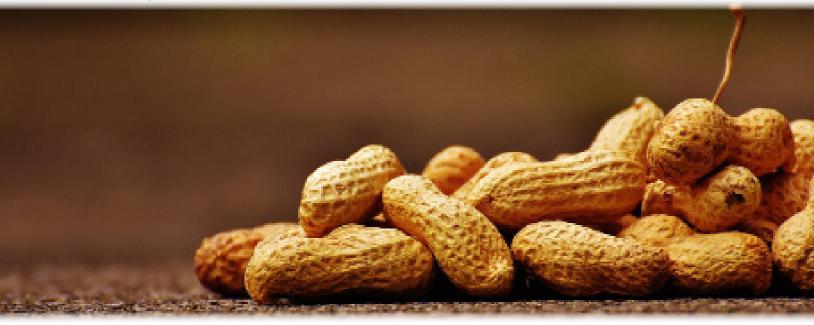
The bucket elevator at a major peanut processing facility was not performing to capacity due to poor bucket fill and discharge. Peanut skins and meal stuck to the blue polyethylene buckets provided by the elevator manufacturer causing peanuts to spill out of the buckets resulting in reduced capacity. The spilled peanuts would build up in the elevator boot where they would become ground up into a pasty meal that also stuck to the buckets.

The peanut meal build-up in the buckets reduced capacity and damaged the peanuts to the point that the elevator had to be shut down every three to four weeks to have all the buckets washed and the boot and head pulleys cleaned to reduce damage to the peanuts and improve system capacity. The elevator incorporated a solid drum style boot pulley that made the situation worse as peanuts fell between the boot and pulley.

Replace blue unvented CC-HD 9 X 5 Polyethylene buckets with 4B CC-S 9 x 5 Urethane elevator buckets incorporating vent holes. Replace boot pulley with self-cleaning wing style pulley.

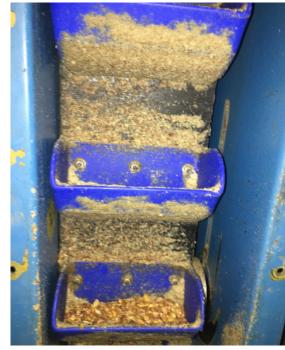
Peanut Build-Up Inside Buckets

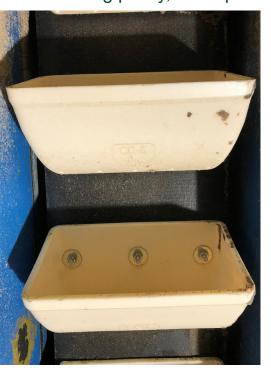
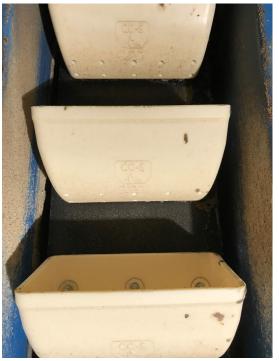
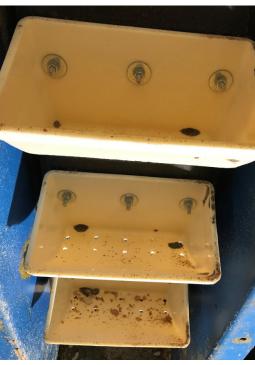
4B CC-S Vent #3 Urethane buckets virtually eliminated the need for bucket clean out and pulley washing. The anti-stick properties of urethane combined with the bucket venting helped prevent material build-up and improved bucket fill and product release. The venting allows the air that would normally be trapped in the bucket to escape and even small peanuts including splits stay in the bucket until they reach the discharge point. Elevator downtime and maintenance was further improved with the installation of the wing pulley, since peanuts were no longer trapped between belt and pulley.

**Elevator info:** Elevator with PVC25010" wide belting punched on 8" spacing for CC-S 9 X 5 Urethane Vent #3 buckets. Self-Cleaning Wing style boot pulley.
