UPGRADE OF CHAIN CONVEYOR FOR CORROSIVE PRODUCTS

Extension of chain conveyor lifetime through choice of chain components

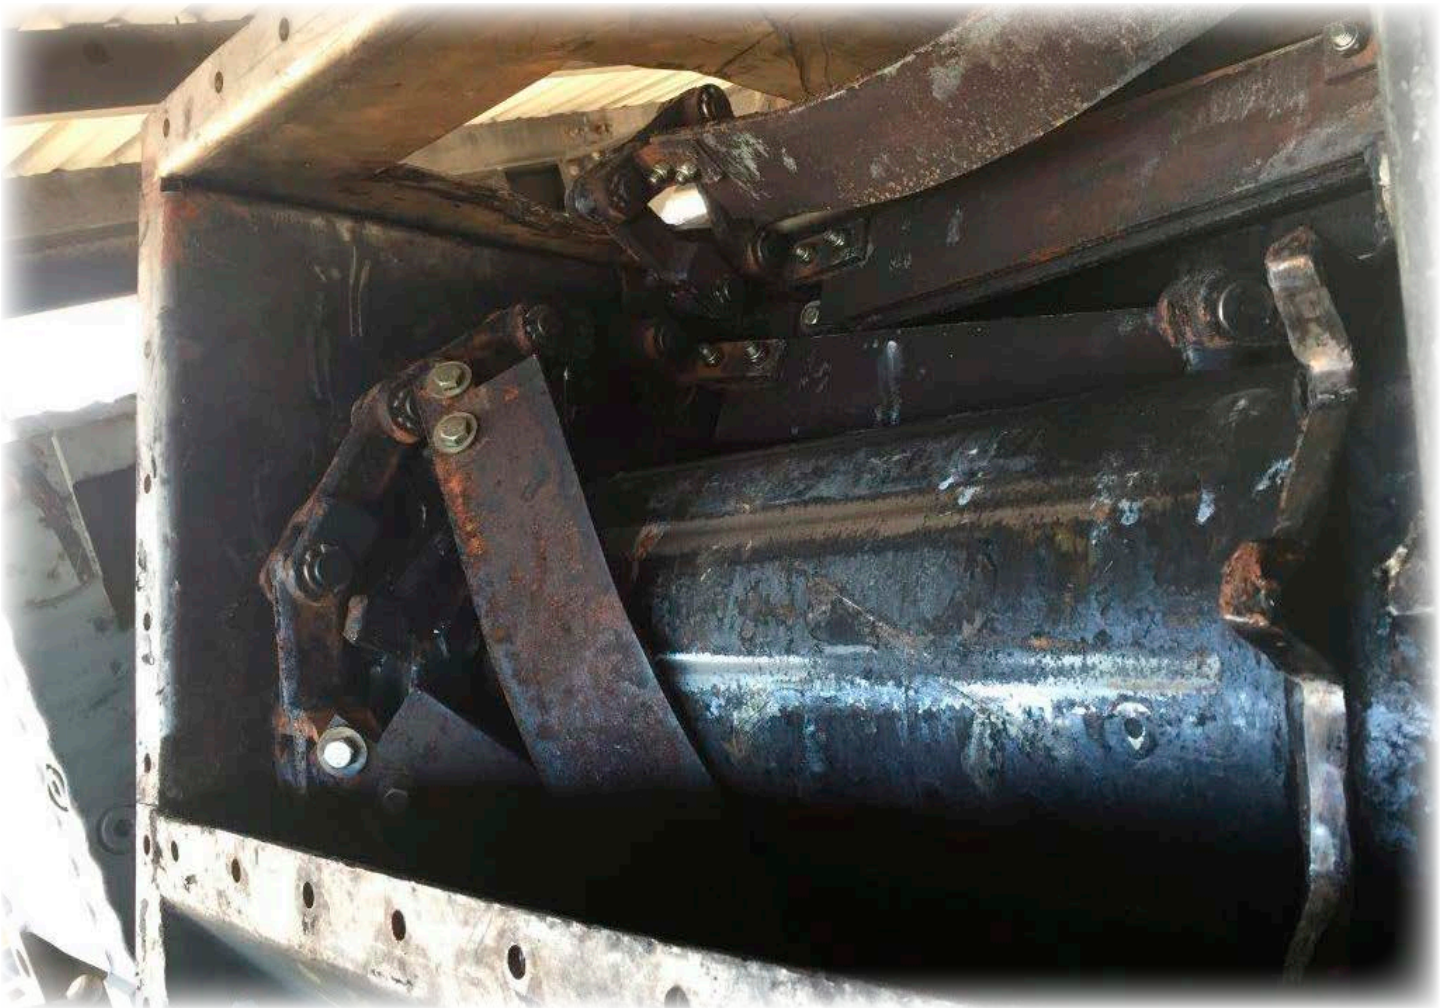
Our customer was struggling with the life of the chain inside their chain conveyors. The chain conveyors were transporting a by-product of crude oil processing and wearing extremely fast. The wear was mainly due to the corrosive nature of the product and the strength of the chain installed.

The corrosion was wearing the chain links and pins quite rapidly and the low chain strength led to rapid elongation of the links. These 2 issues combined resulted in many chain breaks and a lot of production time loss to maintenance on the conveyors.

We offered the 4B142HAD chain links with pins in AISI420 and circlips in AISI304. These pins had a higher resistance to corrosion and the HAD link is 33% stronger than the standard HA link. Because the link is through hardened, it remains quite strong in its core, even if the outer layer wears away. The chain solution was coupled with new sprocket segments made from Hardox 450 and treated to improve the corrosion resistance.

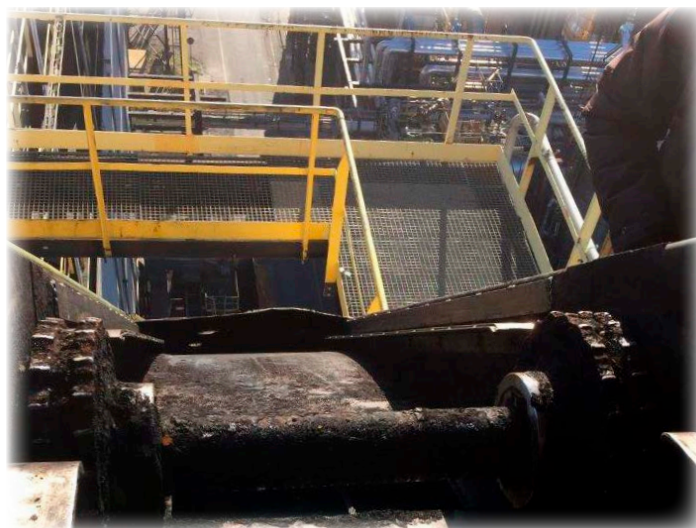
The changes made to this chain have improved the life of the chain conveyor by at least 50%. These improvements are more substantial when the maintenance of the conveyor is more frequent.
