**4B GROUP**

## BREWING & MALTING

Elevator Design Improvements  
Provide advice for re-design

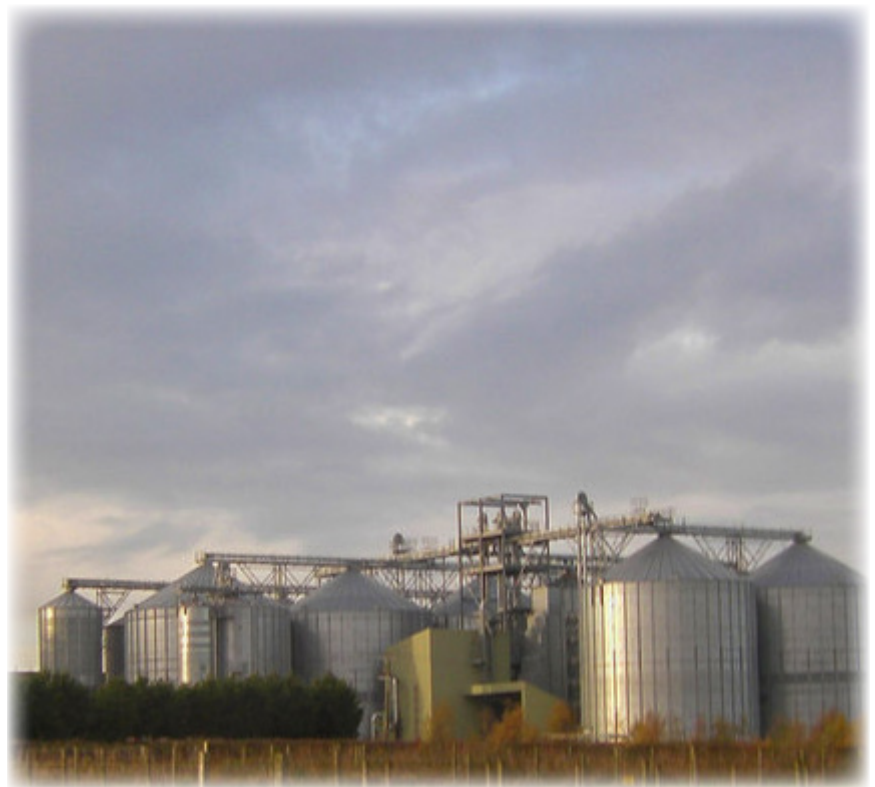
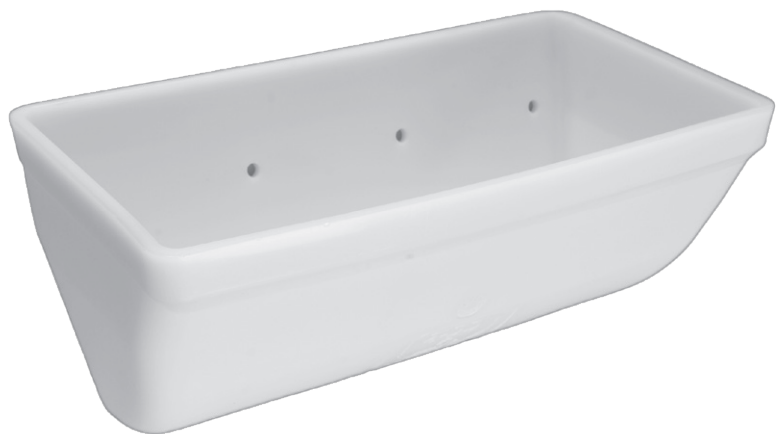
After installation it was apparent the elevator was problematic and not functioning as expected. The installed buckets were CCS127 buckets, which replaced the obsolete J127 HDP buckets which were originally installed

After some discussion with 4B, the prognosis was the pulley may be too small for the projection of the CCS12x7 bucket. This was expected to be cured by installing CCS 12x6 but the problem still persisted although not as bad.

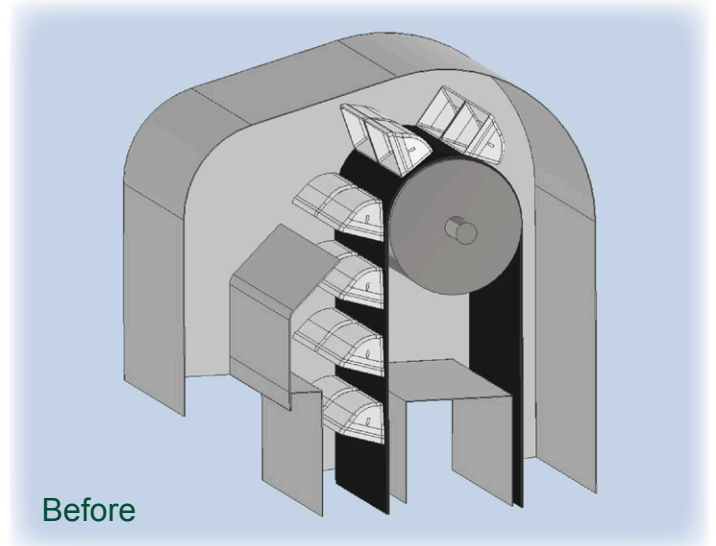
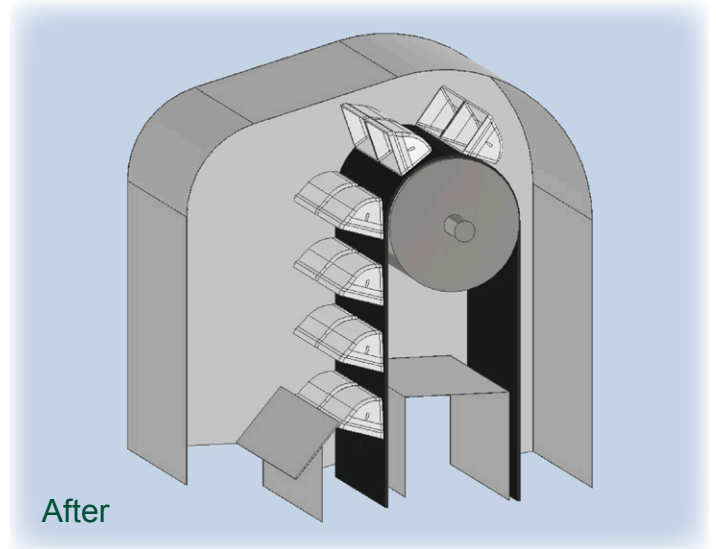
After a site visit to inspect what they actually had, it was apparent the elevator was set up to transport free flowing grain. This setup was incorrect for the handling of green malt, which by nature is wet and sticky and does not flow well.

The conclusion was the product was not fully discharging into the outlet but was in fact falling down the return leg back into the boot.

1. Modify the outlet by lowering it into a suitable position to ensure complete discharge of the product from the bucket into the outlet.
2. Reduce the RPM of the pulley to give the correct discharge stream.

**After implementation of both these modifications the problem completely ceased to exist. The feedback was positive. The elevator ran smoother with less loading on the motor. The batch time was reduced to the point where it is now the most efficient part of the process.**
